MILFORD TOWN DAM
NH 00312
NHWRB 159.02

PHASE I INSPECTION REPORT
NATIONAL DAM INSPECTION PROGRAM

APRIL 1979

Identification No.: NH 00312
NHWRB No.: 159.03
Name of Dam: MILFORD TOWN DAM
Town: Milford
County and State: Hillsborough, New Hampshire
River: Souhegan River
Date of Inspection: November 1, 1978

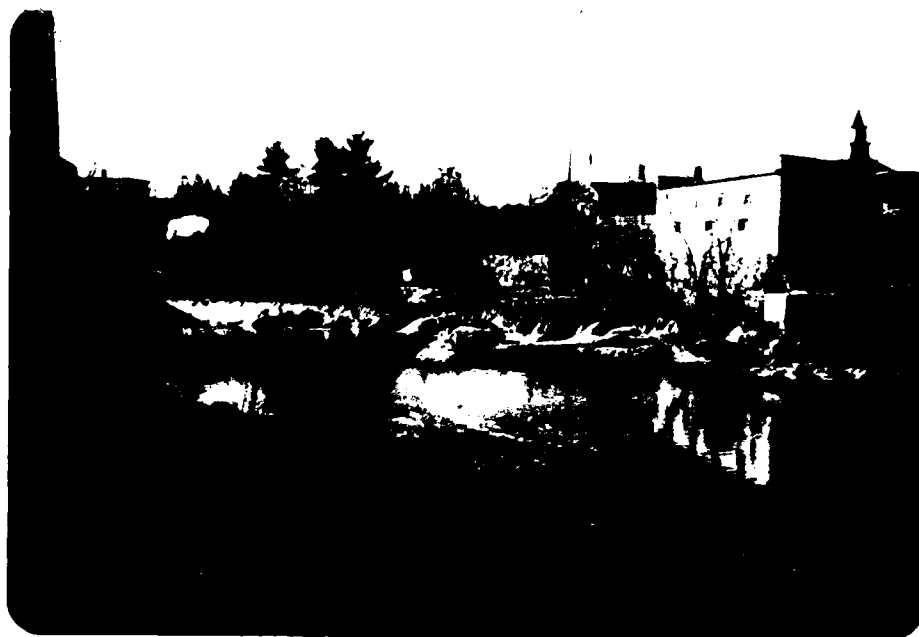
Overview of dam from right side of downstream channel

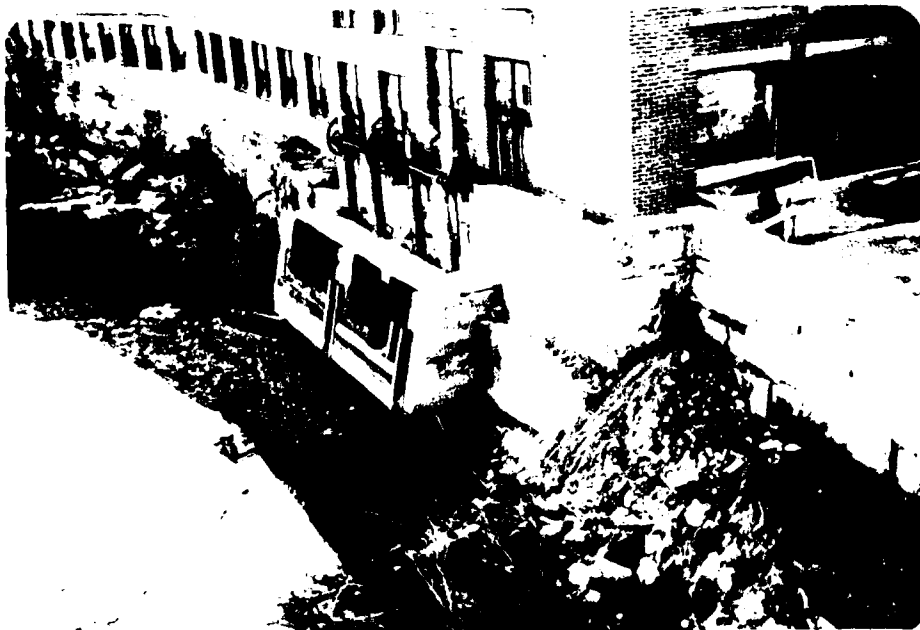
At present both sluice gates are rotted and inoperable. The operating mechanism of the gate on the downstream side consists of 2 hand wheels. The other gate was operated by a steel rod placed in a sprocket which actuated a spindle gear. Upstream of the sluice gates are timber stop logs six inches thick set in "Z" shaped guides at an approximate batter of 4 horizontal to 12 vertical. The tops of the stop logs are approximately 3 feet above the crest elevation. The stop logs are in good condition.

Vertical steel trash racks are set between the gates and the stop logs. These trash racks are rusted, and one panel is missing from the upstream intake. Penstocks connect the sluice gates to the former power generation equipment. The method used to seal the penstocks could not be observed. The outlet from the building is located approximately 150 feet downstream of the spillway.

The intermediate pier above the stop log guides and the downstream wall of the structure is spalled over 10 percent of its surface area.

The roof has spalled over 50 percent of its surface area. This spalling is attributed to moisture intrusion which has been subjected to alternating freeze and thaw cycles. The downstream wall has a continuous horizontal crack approximately 3 feet above crest level which is effloresced. The exposed concrete of this structure is eroded for a vertical distance of 2 feet above crest level. The erosion is attributed to ice damage.

The stone masonry wall adjacent to the intake structure (Photo 2) is founded on a 10 foot long concrete foundation. The concrete is eroded over the entire interface with the cemented stone masonry wall. This erosion is up to 12 inches deep. Approximately 10 feet of the adjacent upstream wall has been undermined and settled. Stepped cracks up to 3 inches high are visible. Random fill has been placed in front of the wall. The remainder of the wall does not show any evidence of displaced stones, bulges, or other signs of distress. The mortared joints are effloresced.

The concrete (Photo 2) located between the right intake structure and the cemented stone masonry wall has a series of horizontal cracks and is effloresced. The cracks are located about 5 feet above the spillway crest. The downstream continuation of the wall is approximately 15 feet high and serves as the building foundation wall. The wall is in good condition with no evidence of displaced stones, bulges, or other signs of distress. The mortared joints are effloresced.

2. View from upstream road bridge showing abandoned inlet structure

It is recommended that the owner retain a registered professional engineer to determine if the right intake structure is adequately sealed. Appropriate remedial measures should be taken following the investigation.

- (1) Repair the deteriorated concrete on the right intake structure.
- (2) Monitor by visual observation the seepage at the base of the intake structure and building for changes in flow quantity or turbidity which may require remedial action.
